Road Surface Rehabilitation Ayrton Senna Highway (SP-070) — São Paolo, Brazil

Project Category Road Surface Rehabilitation

Simpson Strong-Tie Products Carbophalt[™] G pre-bituminized asphalt pavement reinforcement grid

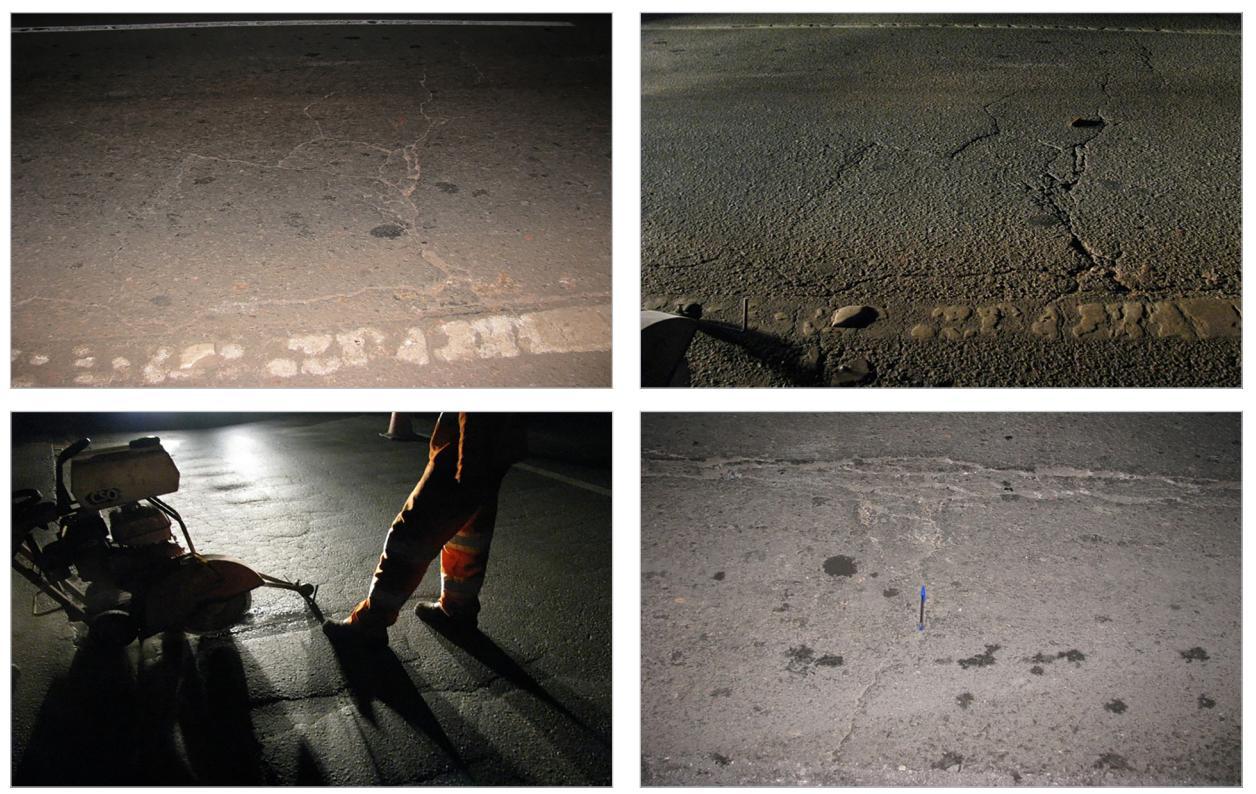
March 2011 — Highway inspection. The highway inspection revealed that there was severe cracking on the road surface prior to the installation of reinforcement grid.

Such indispensability, however, can come with a cost over time. By 2010, the freeway's 10" (25 cm)-thick cement-stabilized base course was severely cracked because of the high traffic volume (approximately 90,000 vehicles daily each way) and the unstable subsoil on which the road rests. Damage in the base course created reflective cracking in the asphalt wearing course, which had to be resurfaced almost every six months at substantial recurring costs, not to mention frequent disruptions to the freeway's use.

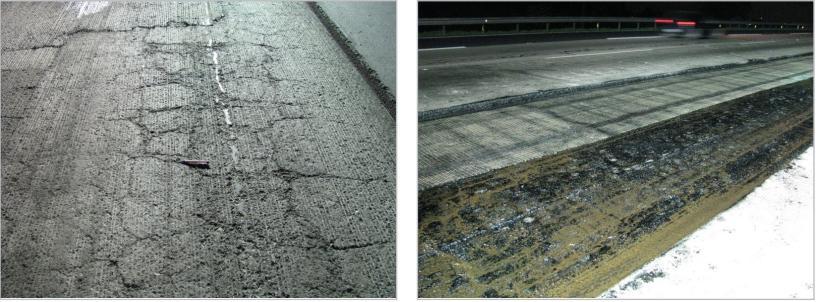
April 2011 — Lane four repaved with asphalt reinforcement grid. The road surface was milled and the asphalt reinforcement grids were laid onto tack coat.

In April of 2011, Simpson Strong-Tie Carbophalt[™] G asphalt reinforcement grids were installed on various sections of the highway's busiest lane, lane four.

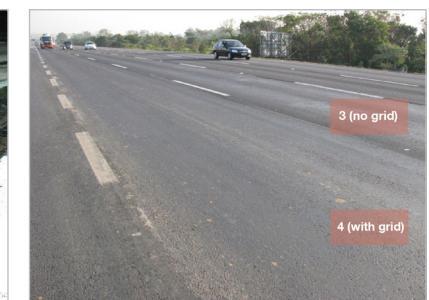
May 2011 — Lane three repaved without asphalt grid reinforcement for comparison. Lane four repaved with S&P asphalt reinforcement grids in April 2011, Lane three repaved without grids in May 2011.

In order to gauge the efficacy of the Simpson Strong-Tie asphalt reinforcement products, a month later, in May 2011, lane three was also resurfaced, only without any reinforcement grids. Five follow-up reviews of the highway's surface were undertaken in February 2012, September 2012, May 2013, June 2014, and January 2015.

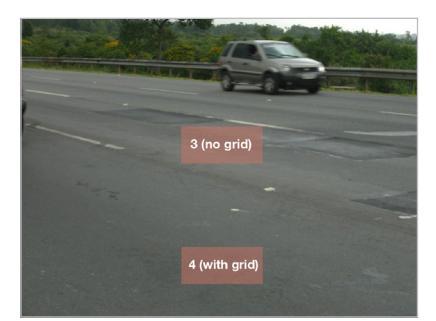
February 2012 — 10 months elapsed. Lane four remained in very good condition. Lane three, however, was already showing signs of degradation and punctual repairs were carried out.

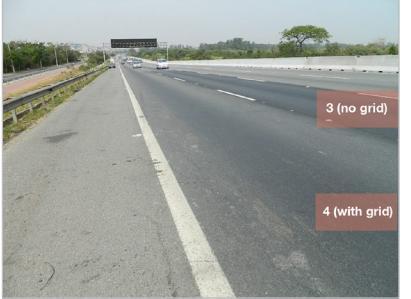
September 2012 — 17 months elapsed. Again, lane four remained in very good condition, but lane three was already completely repaved for a second time.

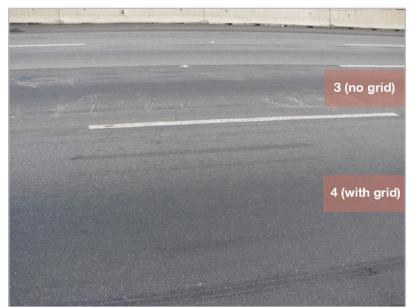
May 2013 – 25 months elapsed. While lane four remained in good condition, lane three was yet again showing signs of heavy damage and in need of repaving for a third time.

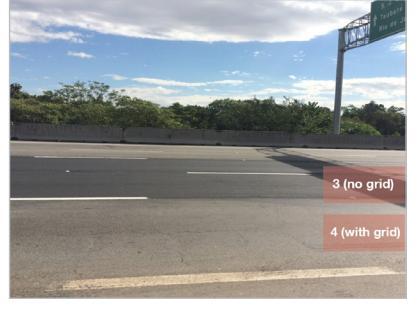
June 2014 — 37 months elapsed. Although light cracking appeared on lane four, it passed the inspection from ARTESP and was deemed safe. Lane three was repaved for the third time.

Results for the Simpson Strong-Tie asphalt reinforcement easily exceeded the project owners' initial expectations. The goal had been to extend the maintenance intervals from six months to a year. But while the unreinforced resurfacing had to be repaired or completely repaved three times in the next three years (by June 2014) because of excessive cracking, the grid-reinforced lane four remained in good condition for better than two full years (through May 2013). By June 2014, light cracks were appearing, but they weren't extensive enough for the lane to be deemed unsafe or in need of resurfacing, and it passed the external inspection by the government transportation agency ARTESP.

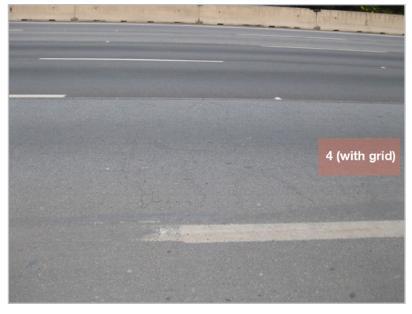
January 2015 — 45 months elapsed. No further degradation of lane four was observed and at least another year of service life was expected.

Almost four years after installation of the reinforcement grids, no further degradation of lane four had been observed in the January 2015 inspection and at least another year of service life was predicted without the need for resurfacing. In August of that year, however, it was decided to alter the road profile to incorporate needed new exits for the airport. The road structure was completely renovated at that time, which included finally replacing the unstable subsoil base. Further project monitoring was therefore no longer possible.
